# UT of Quench Cracks on Guides of Chains for Caterpillars

Ultrasonic Application Solutions

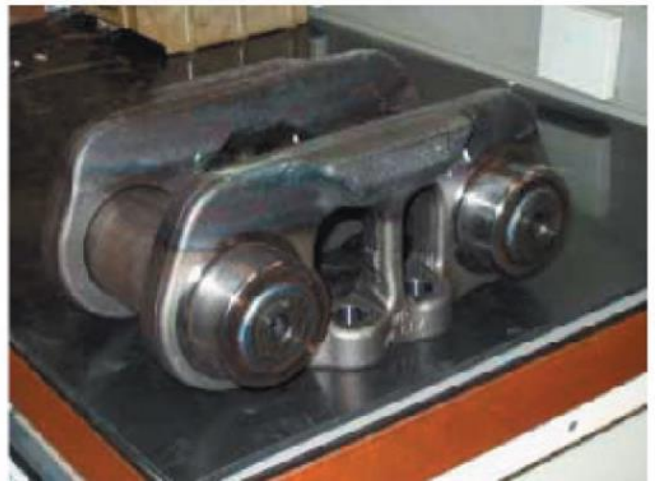
Figure 1: Caterpillar chain

Hardening treatment carried out on caterpillar chain guides can result in the development of quench cracks. These occur on the inner surface and can possibly emerge on the opposite surface. Once the cracks emerge, the defect is easily detectable by eddy current or even by visual inspection. However, these methods cannot detect the cracking before it reaches the surface.

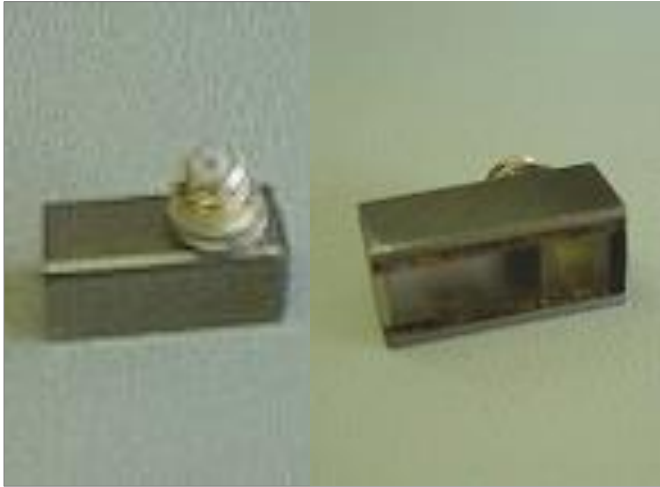
Figure 3: Subminiature angle beam probe

SMWB 45-4 is a subminiature angle beam probe with a frequency of 10MHz for a good resolution and the beam exit point is located as close as possible towards the rear of the housing. The selected angle is 45° shear. This probe is very small with a width of 7mm and a length of 16mm.

To detect this kind of defect, an ultrasonic inspection is used along with an angled probe. This method is fast, easy and effective. The angled probe developed for this application has small overall dimensions while being easy to handle. It has a crystal of 10MHz for good resolution and the beam exit point is located as close as possible towards the rear of the housing. The selected angle is 45° shear. This kind of probe allows for the detection of defects under 0.5mm.

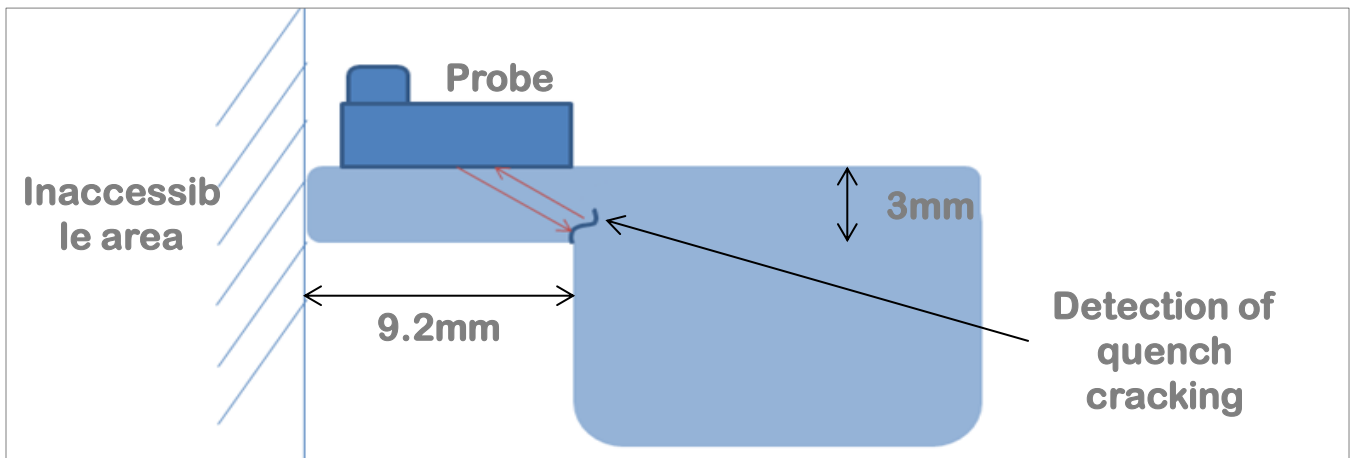
Figure 4: Measurement setup
