Wall Thickness Measurement on Cast Camshafts

Ultrasonic Application Solutions

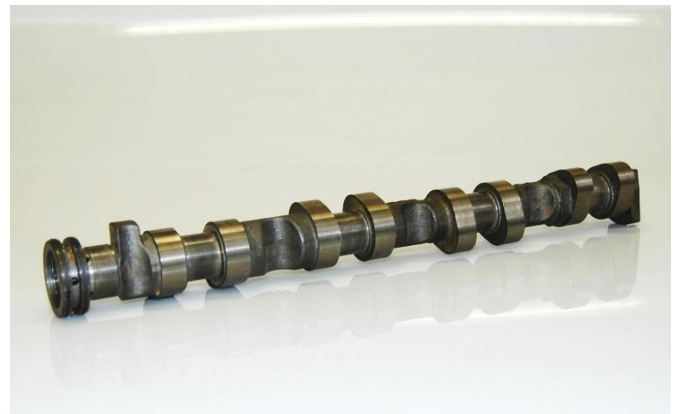
Figure 1: Cast camshaft

A nondestructive method is required to detect “core mismatch” - a common casting defect.

As a consequence of this mismatch, reduced wall thicknesses occur leading to a failure of the camshaft in operation because of its lean geometry and due to the extreme dynamic load.

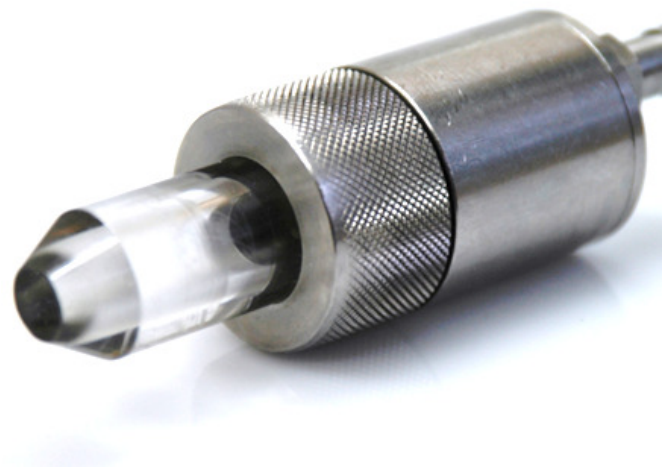
Figure 2: Probe used for camshaft inspection

The ultrasonic flaw detector USM 36 & probe H 2 KF

The recommended solution is to measure the wall thickness on the bearing points. The annular geometry of these points makes it possible to carry out the test on the as cast shaft. Further unnecessary processing of any defective parts is thus excluded. This method makes it possible to recognize the core mismatch by a changing wall thickness around the circumference. The waterflow (squirter/bubbler) technique is applied according to the arrangement shown in Fig 3. This ensures constant coupling in the area of the bearings around the entire circumference during camshaft rotation.

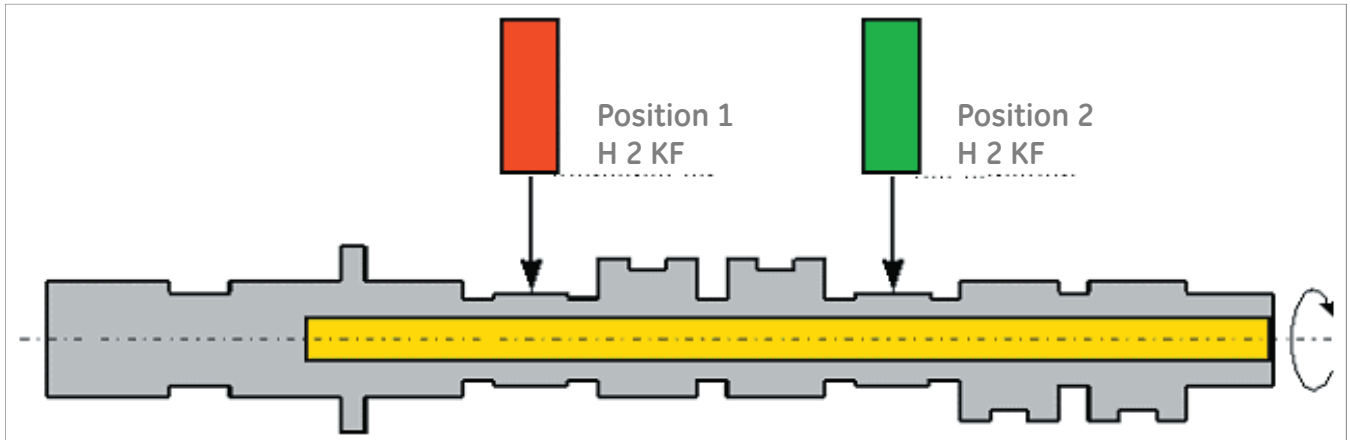
Figure 3: Circumferentially developed view

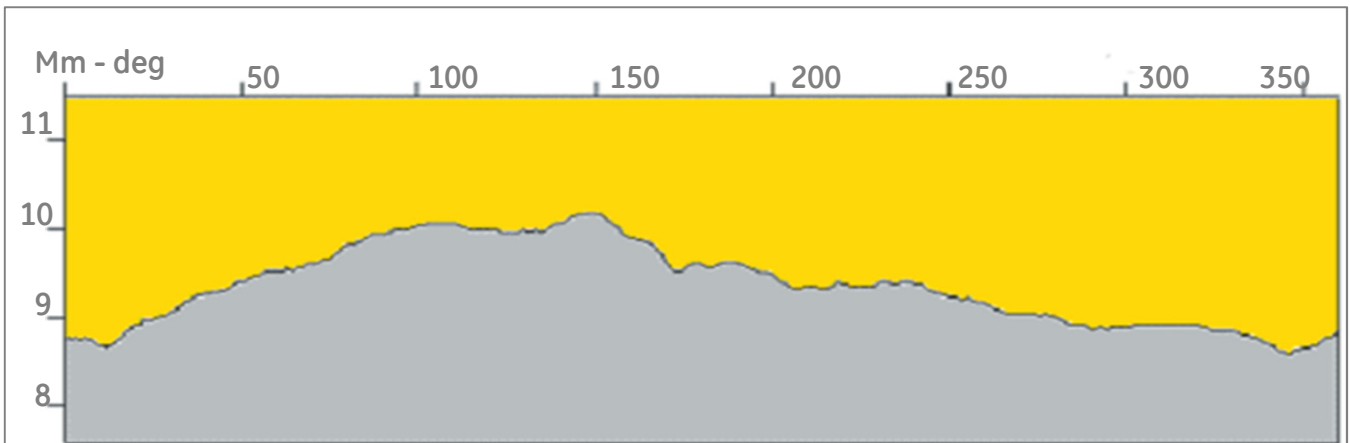
Figure 4: Typical linear scan, varying wall thickness: $\Delta d \sim 2.6$ mm
